260-SL-3 MOTOR PROGRAM

VOLUME I: 260-SL-3 Motor Internal Insulation System

FINAL PHASE REPORT

28 April 1967

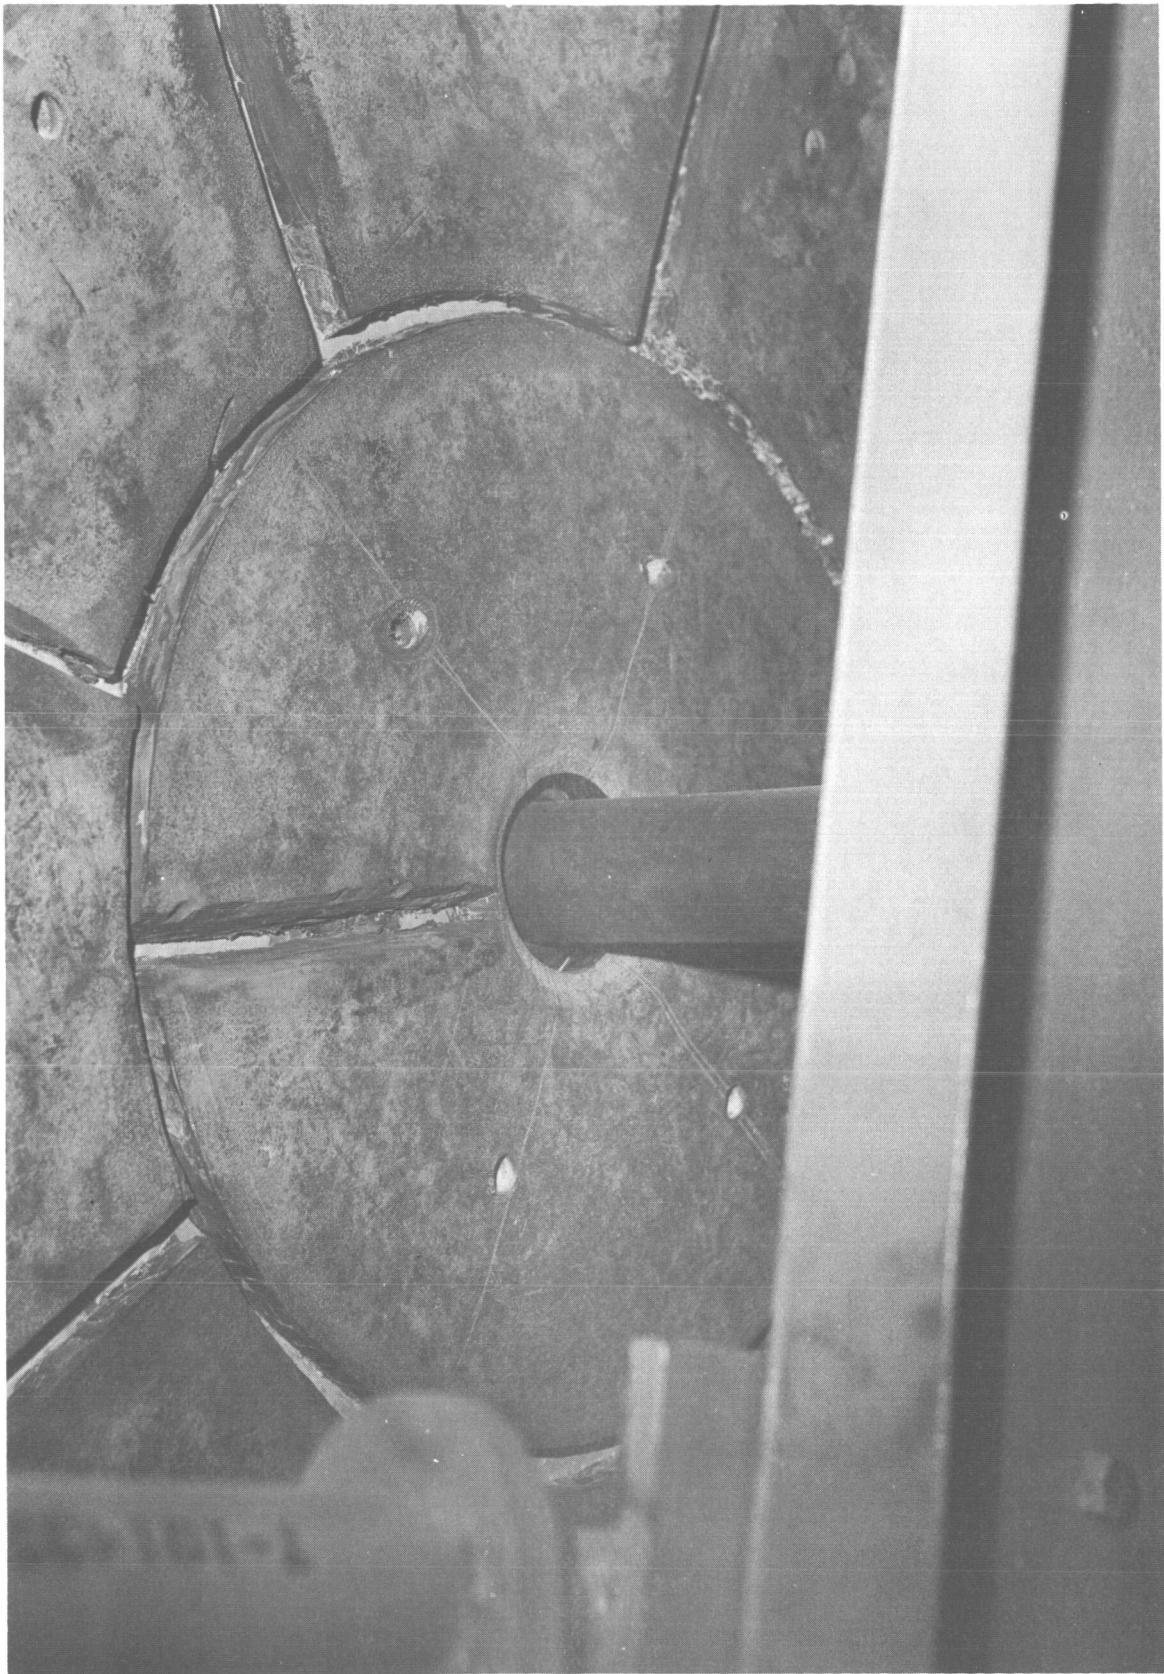
Figure 10

The first operation after the chamber was returned to the General Processing area was to remove the V-61 potting insulation from the forward and aft insulation segment V-grooves. This proved to be the most difficult operation. To use routers would be time consuming, and the use of electric saws presented the hazard of inadvertently contacting the metal surface. Hence, the material was manually removed by using rubber mallets and aluminum chisels. This technique resulted in cuts and gouges in the sides of the rubber V-groove, and total removal of the V-61 was not possible. A power sander was equipped with an aluminum saddle, extending approximately 0.13-in. beyond the abrasive wheel. The aluminum saddle was indexed on the chamber wall at the base of the V-groove and prevented the abrasive wheel from contacting the metal surface. This method was successful in removing almost all of the V-61 in the grooves. In inaccessible areas close to the chamber wall or where the V-groove base was narrow, traces of V-61 remained. Completed forward V-grooves are shown in Figures 10 and 11. After acceptance of V-61 removal, the metal at the base of the V-grooves was gritblasted to remove the primer, cleaned, and reprimed with Fuller 162-Y-22. In this limited access area, the primer was brush-applied to prevent contamination of the adjacent rubber.

Forward Insulation V-Grooves After V-61 Removal

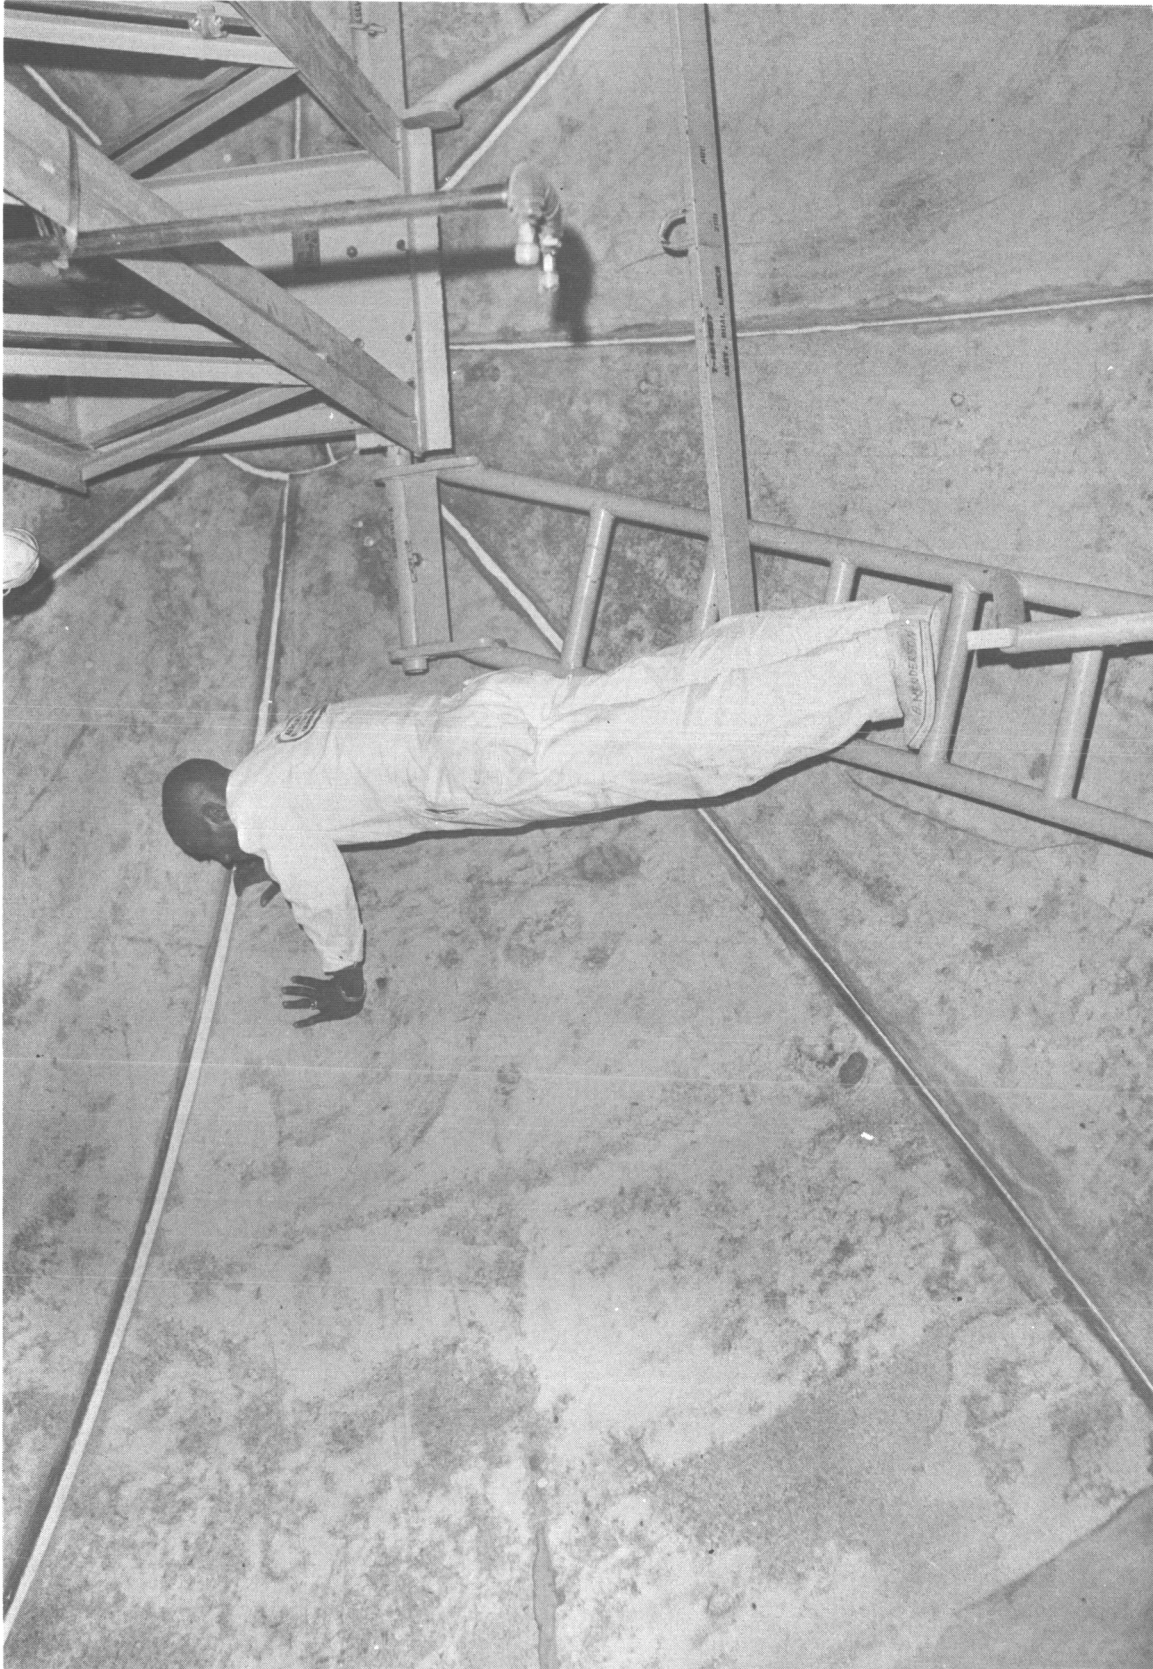
Figure 11

Forward Insulation V-Grooves After V-61 Removal

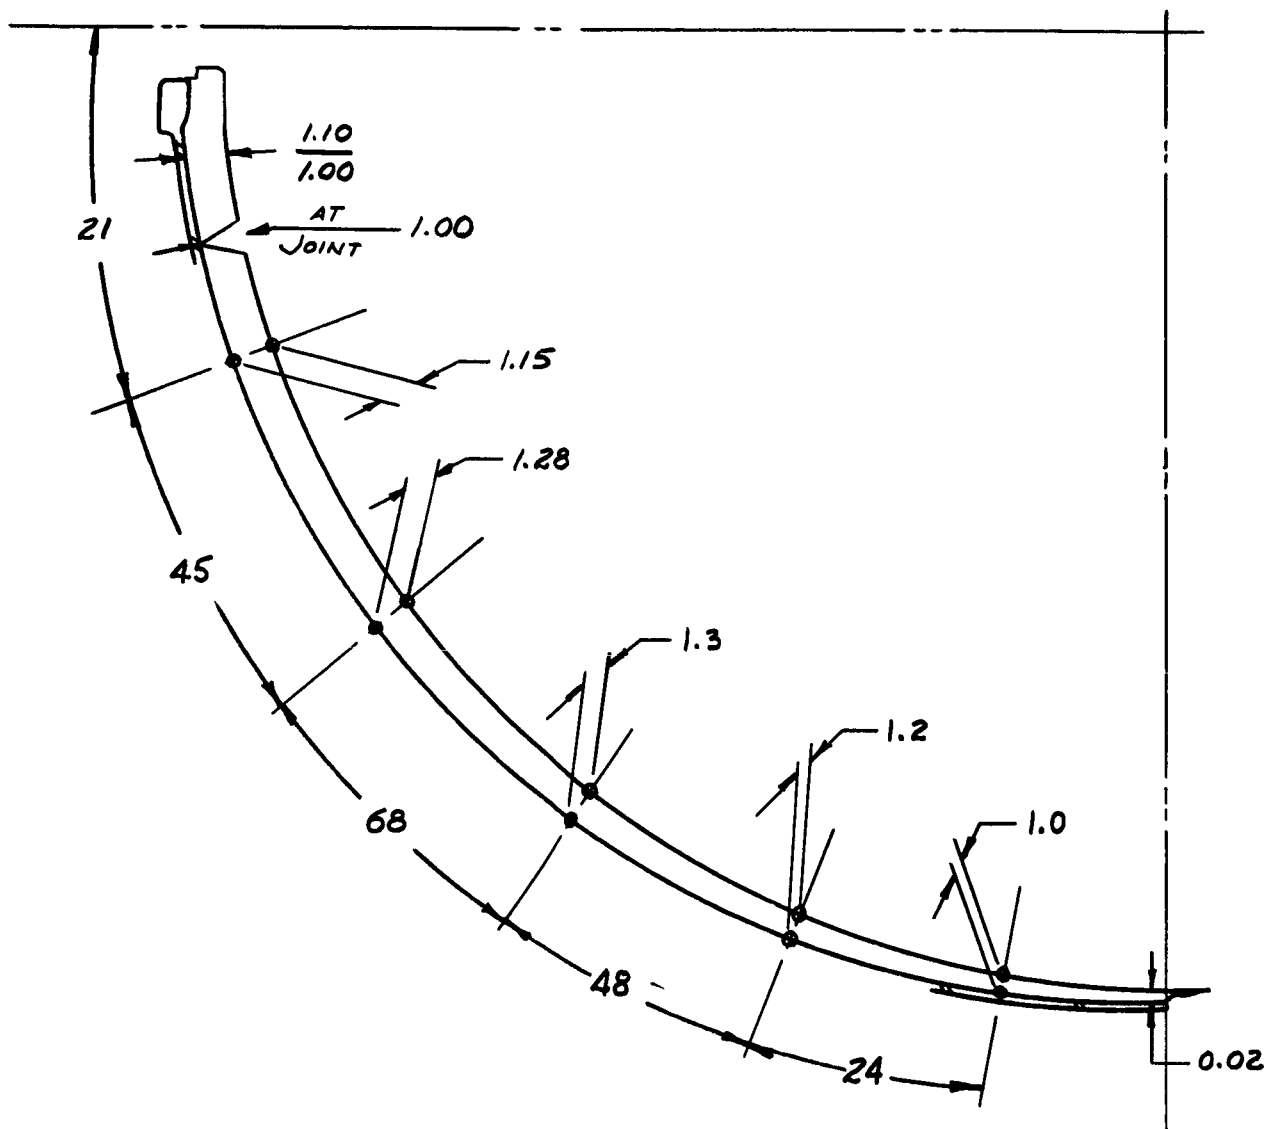
Figure 12

Final 260-SL-3 Rehabilitated Forward Insulation Contour

The areas in the forward and aft insulation where damaged rubber had been removed were repaired with V-44 strips. Residual cylindrical-section strips were cut to the required dimensions and bonded into the areas with Epon 948.2 adhesive. Additional insulation sheets were bonded over the initial layer until the area being repaired was built up flush with the adjacent insulation surfaces. The laminated steps were buffed to eliminate sharp corners and smooth out the contour. A router was used to grind out the surface defects in the aft insulation.

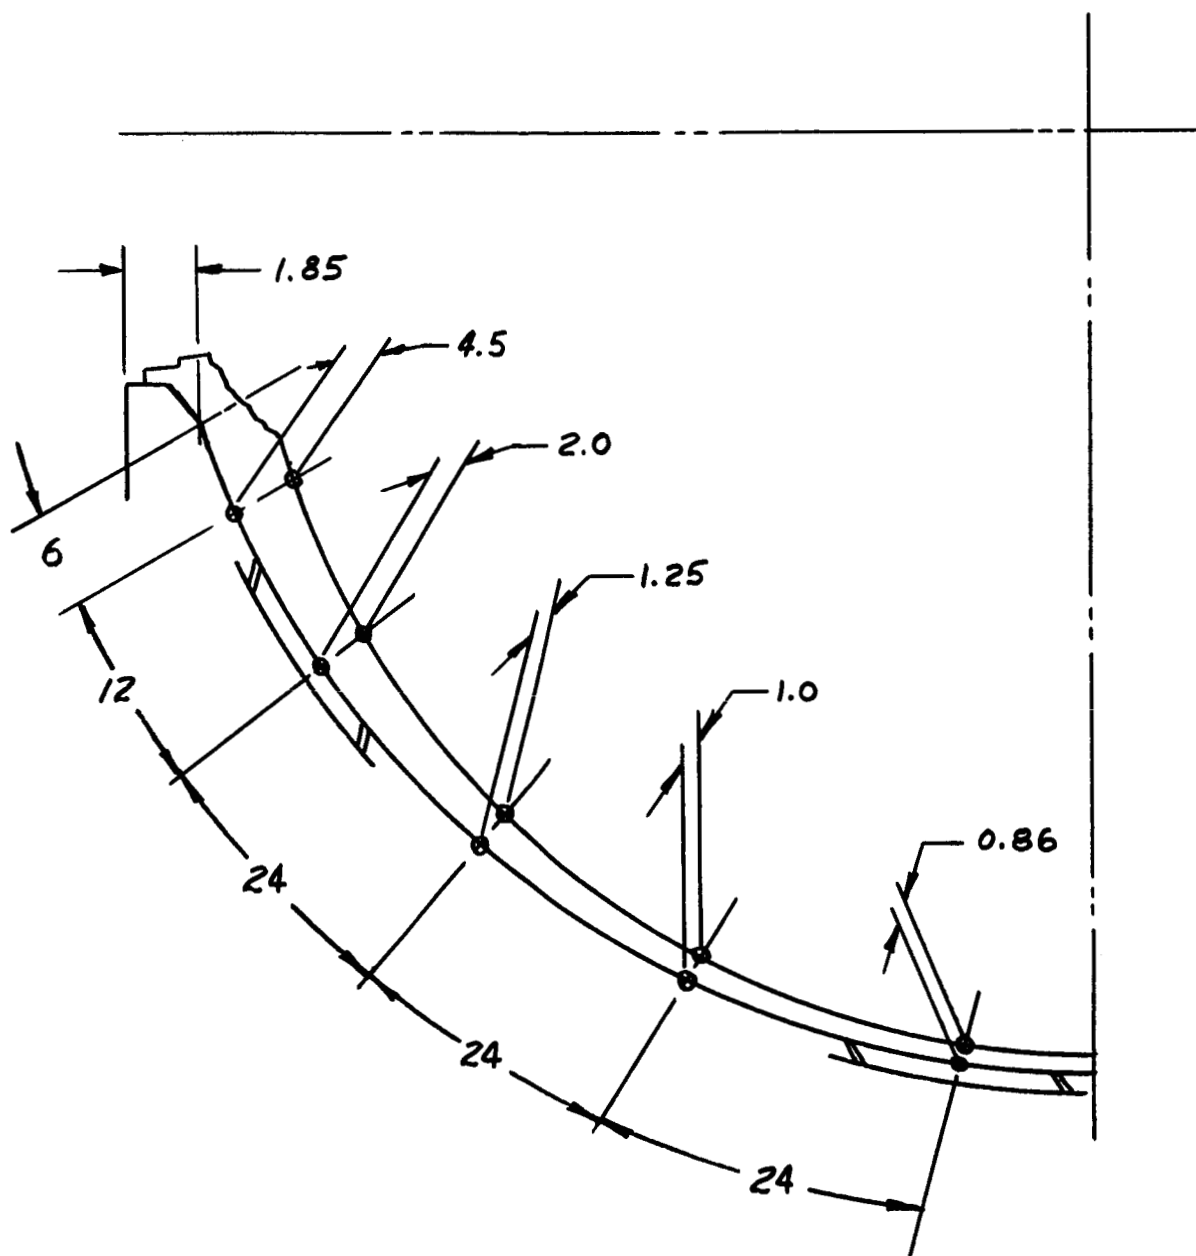
Final 260-SL-3 Rehabilitated After Insulation Contour
Figure 13

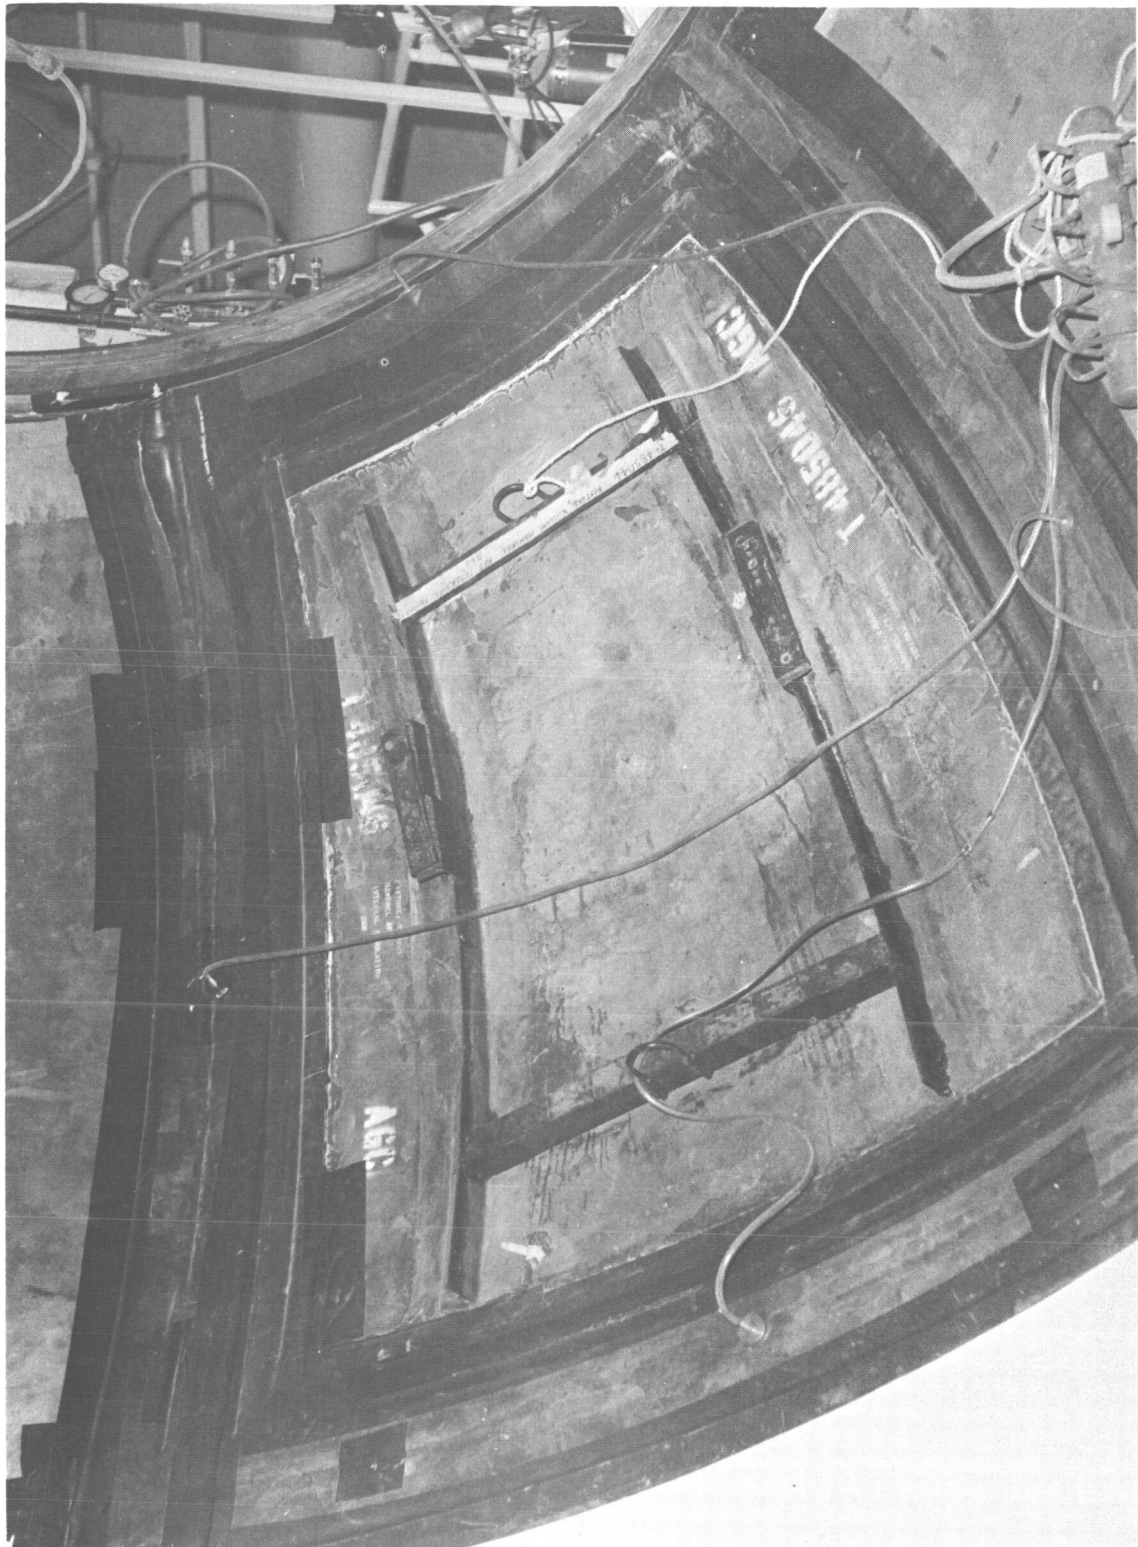
Figure 14

Replacement Aft Insulation Segment Under Vacuum Cure

Installation of the replacement segment, S/N 260A-6, was accomplished as planned. A heavy-gage aluminum-foil template was laid up in the area where the segment was to be installed. The template was removed, placed over the replacement aft insulation segment, and the segment was trimmed to the template configuration. The trimmed segment was moved into the chamber and checked for final fit. The sides of the segment were retrimmed where necessary, skived to 30 degrees using a power sander, and the bonding surface was abraded. Fifty lb of Epon 948.2 was mixed and applied to both the segment and chamber bonding surfaces. No. 1502 cotton bleeder cloth was applied to the chamber epoxy surface, and the segment was installed. Blankets were installed and dealed around the periphery, and vacuum was drawn. The adhesive was cured for 12 hr under 25-in.-Hg vacuum, as shown in Figure 14.

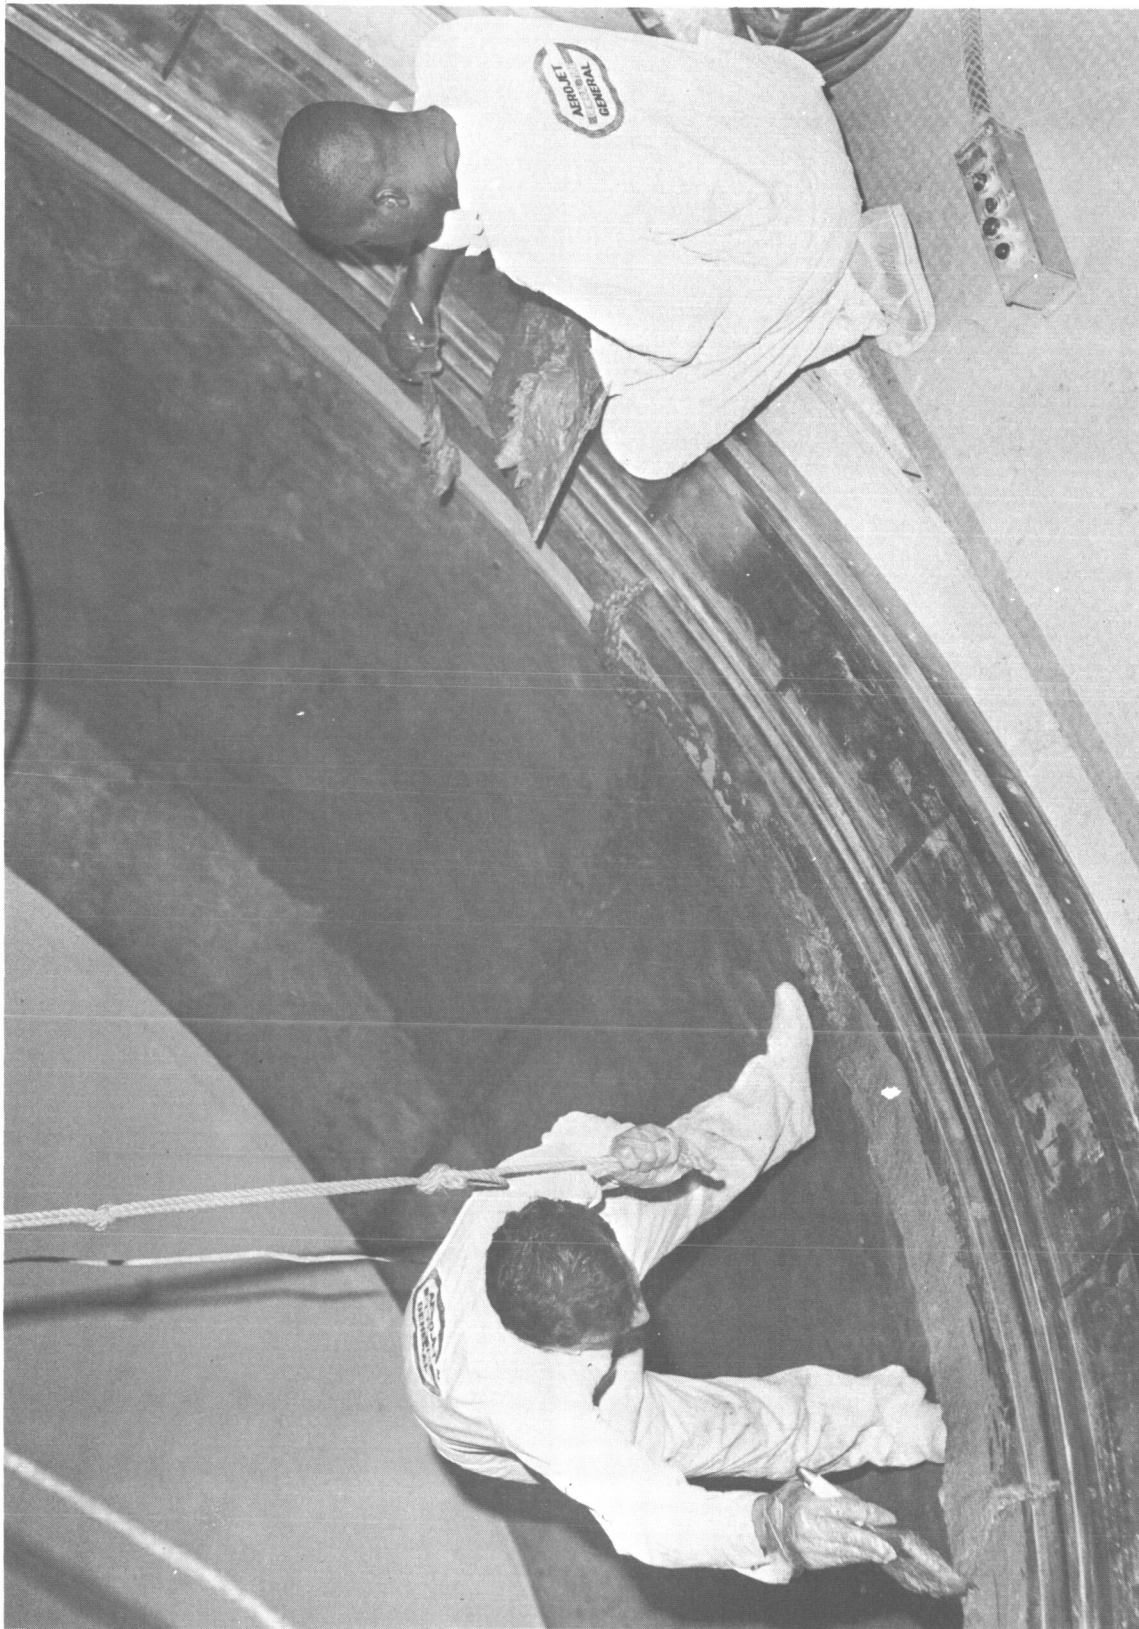
Figure 15

original or thin configuration (2.76-in. thick at the step-joint) used in motor 260-SL-2. The existing aft insulation in the S/N 001 chamber was 4.26-in. thick at the step-joint. Since the step-joint of the existing insulation was to be built-up to the original thickness with V-61, the decision was made to use the available aft segment as a replacement and to build-up its contour with V-61 material.

Aft Step-Joint Build-Up with V-61 Potting Insulation

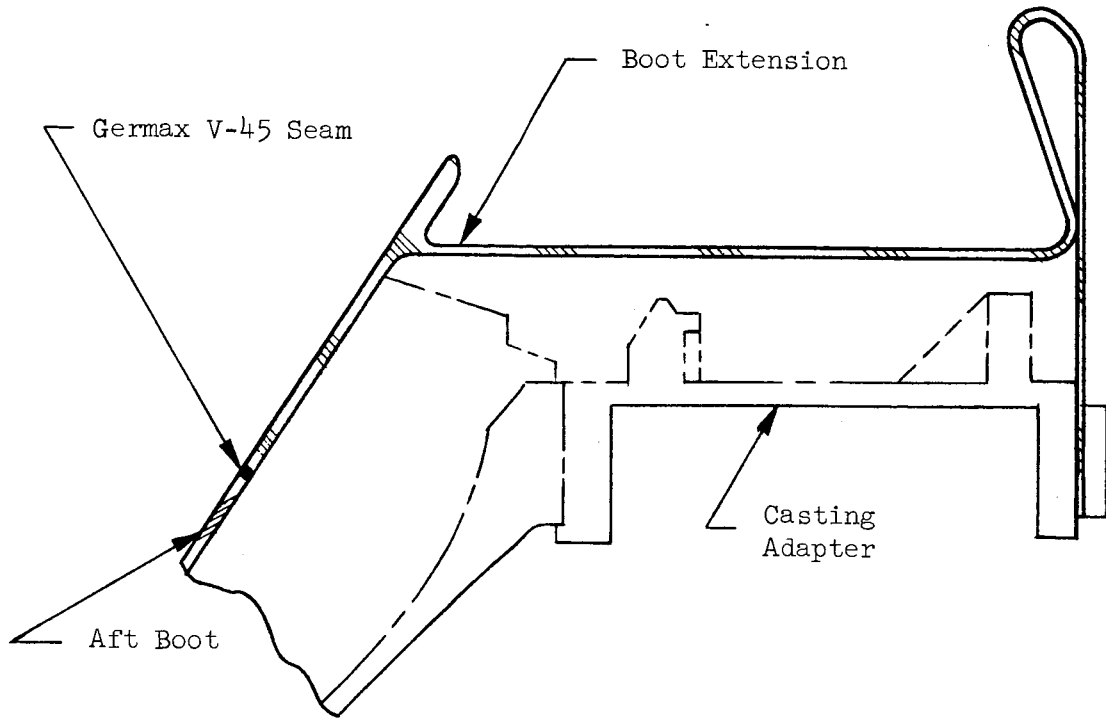
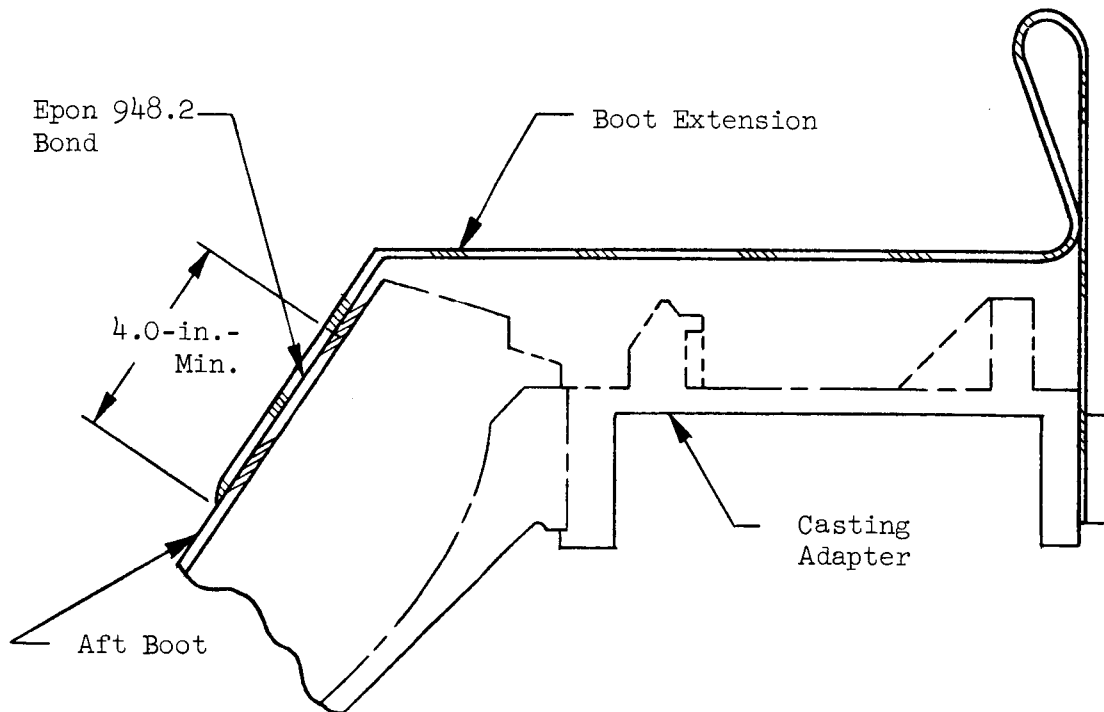
Revised After Propellant Boot Extension Configuration

When the vacuum blanket was removed after cure, there were several areas where the extension had pulled away from the boot, leaving a 0.18- to 0.25-in. gap. These bond defects were repaired by sanding off the cured epoxy, cleaning the area, and injecting fresh Epon 948.2 into the unbonded area. A vacuum blanket then was installed over the area, and the repair was cured under vacuum.
